Manhole Inspection Summary

Manhole # S25Q__011MH

Insp Date: **5/14/09 12:20 PM**

Location Address: **BAYARD ST.**

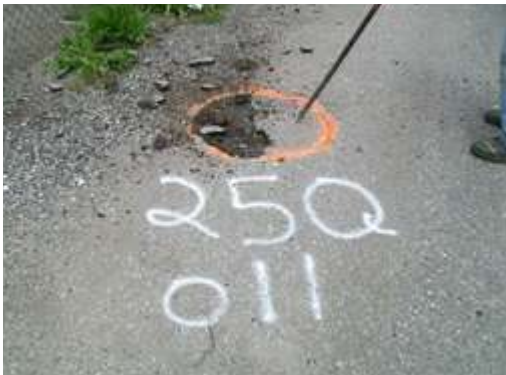
Miscellaneous

MISC. MANHOLE WAS BURIED UNDER ASPHALT.

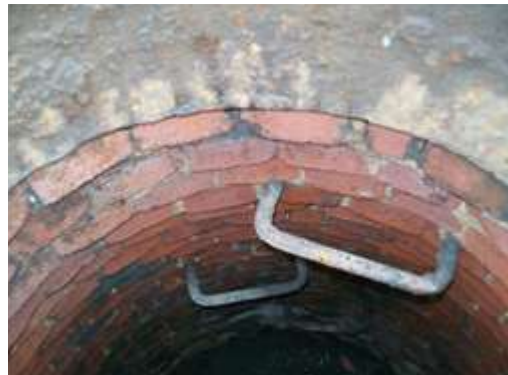
Defect 2

Steps Count: **3** Missing: **0** ☒ **Corroded**

corroded steps

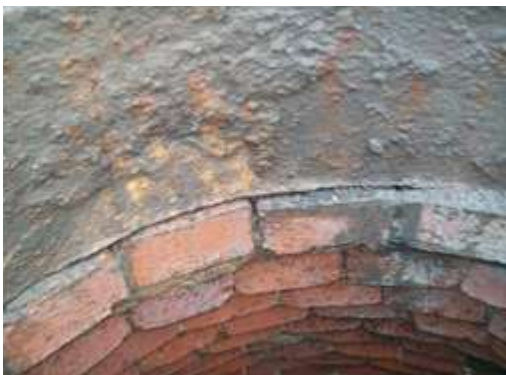
Defect 1

Frame Offset: **0** (in.) Condition: ☐ Sound ☒ **Cracked** ☐ Leaks

APPEARS TO HAVE A CRACK IN THE FRAME

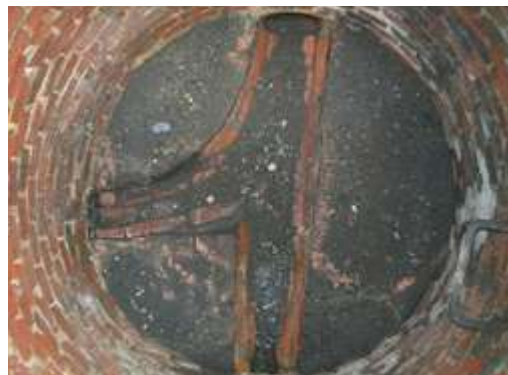
Defect 4

Condition: ☐ Sound ☐ Cracked ☐ Root Intrusion ☐ Deteriorated ☐ Leaks ☒ **Debris**

bench debris

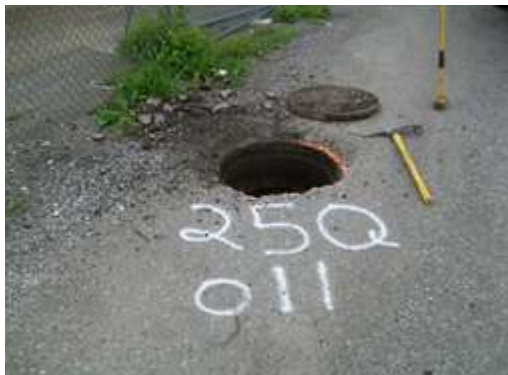
Defect 3

Cover Shape: **Circular** Diameter: **24** (in.) Length: **0** (in.) Dist A/B Grade: **-4** (in.)

cover below pavement by 4inches

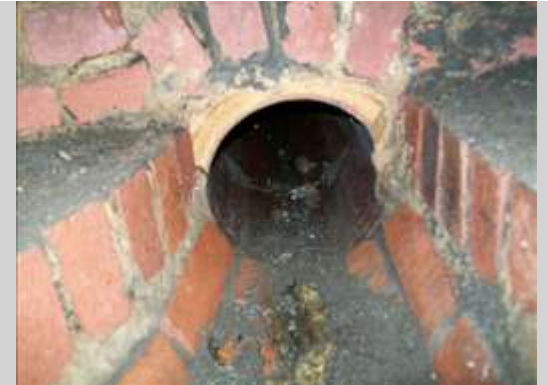
12 O'Clock Outflow

8 in. Circular Gravity Sewer
Pipe Out @ 12 O'Clock

Pipe Height: **8.4** (in.) Rod and Bar (Angled)
Pipe Material: **Clay** ☐ Pipe Lined
Invert Depth: **7.38** (ft.) Flow Characteristics: **None**
Deposits: ☐ None ☐ Mud ☐ Sludge ☒ **Debris** ☐ Grease
Silt Depth: **0.5** (in.) Deposits Extent: **Light**
Infiltration: **None** Pipe Seal Cond: **Sound**

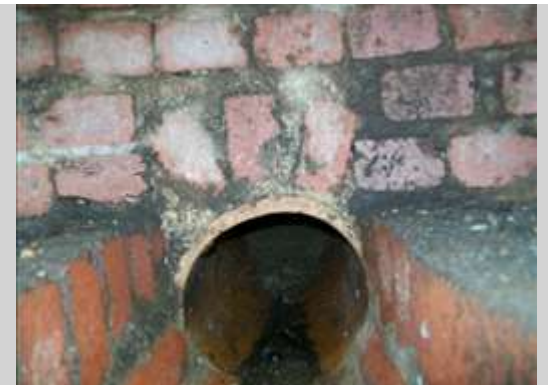
6 O'Clock Inflow

8 in. Circular Gravity Sewer
Pipe In @ 6 O'Clock

Pipe Height: **8.4** (in.) Rod and Bar (Angled)
Pipe Material: **Clay** ☐ Pipe Lined
Invert Depth: **7.24** (ft.) Flow Characteristics: **Slow**
Deposits: ☐ None ☐ Mud ☐ Sludge ☒ **Debris** ☐ Grease
Silt Depth: **0.5** (in.) Deposits Extent: **Light**
Infiltration: **Weeper** Pipe Seal Cond: **Cracked**

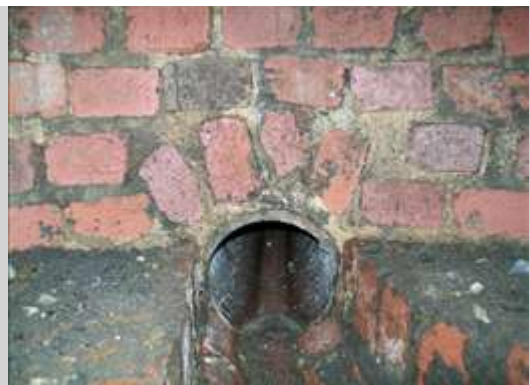
9 O'Clock Inflow

6 in. Circular Gravity Sewer
Pipe In @ 9 O'Clock

Invert Depth: **7.10** (ft.) Flow Characteristics: **Slow**

Deposits: ☒ None ☐ Mud ☐ Sludge ☐ Debris ☐ Grease
